**Industrial Facility
NPDES Stormwater Inspection**

AES PUERTO RICO, L.P.

COAL-FIRED STEAM POWER PLANT AND MARINE CARGO HANDLING DOCK

Inspection Dates: July 16-17, 2018

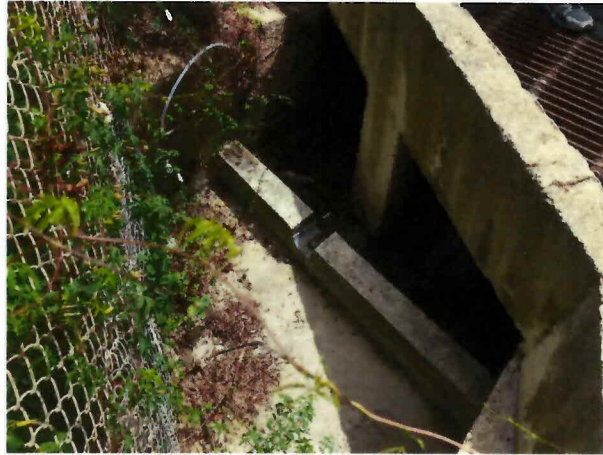
Picture 1

- a. *Outfall 002* – **Picture 1** below depicts the conditions of Outfall 002.

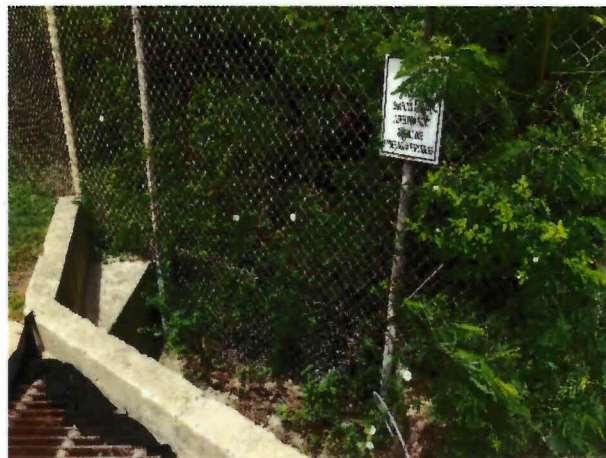
Picture 2

Findings: It was confirmed that the automatic sampling equipment was not available. The sampling point for Outfall 002 lacked good housekeeping, as it contained debris, sediments, vegetation and other floating materials. The discharge location into wetlands lacked good housekeeping. See **Picture 2** below depicting this observation.

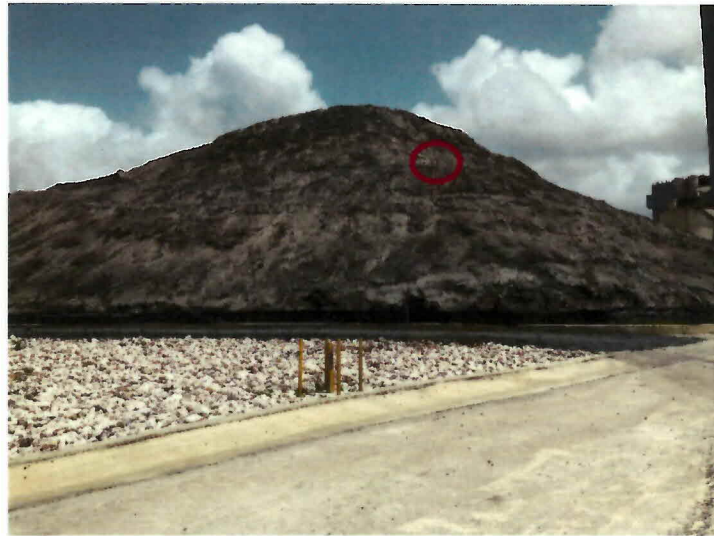
Picture 3

Finding: During the walkthrough, the EPA Inspector did not observe any spraying nozzles in operation to control dust. Mr. González indicated that three (3) of the nine (9) nozzles were undergoing repairs or replacement. **Picture 3** and **Picture 4** are examples that depict this observation.

Note: Southeast view of the CCR storage pile.

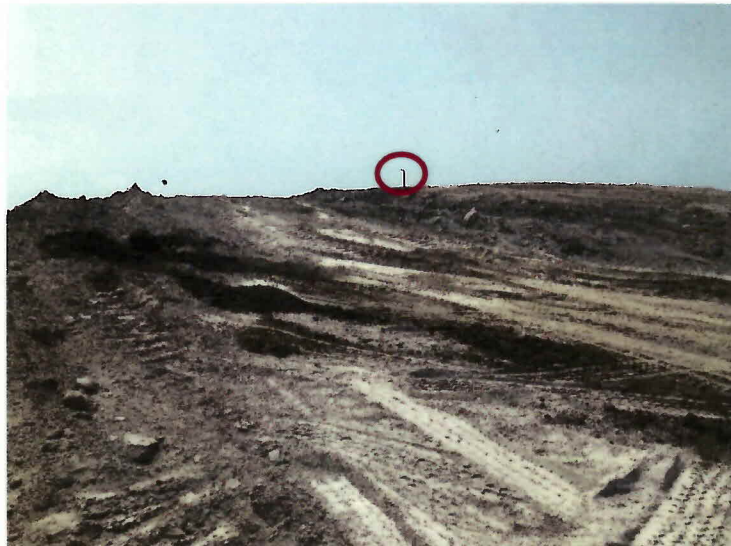
Picture 4

Note: Top of CCR storage pile looking towards the east side of the Facility.

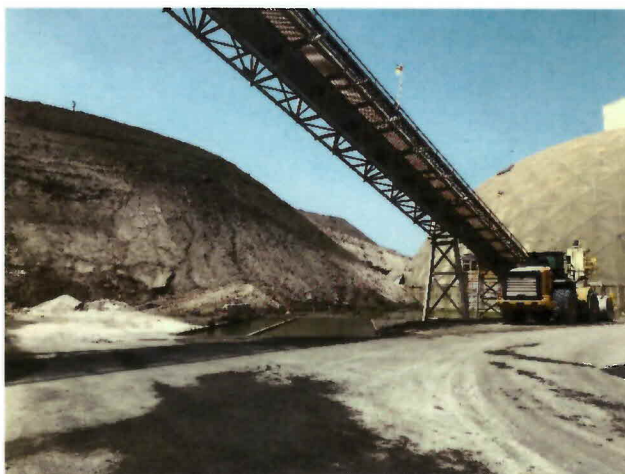
Picture 5

The accumulation and storage at Agremax pile expanded to the west side of the pile to a point in which the pile is in direct contact with the storage dome. **Picture 5** depicts this observation.

Note: The EPA Inspector could walk between the storage pile and the dome during previous walkthroughs of these areas.

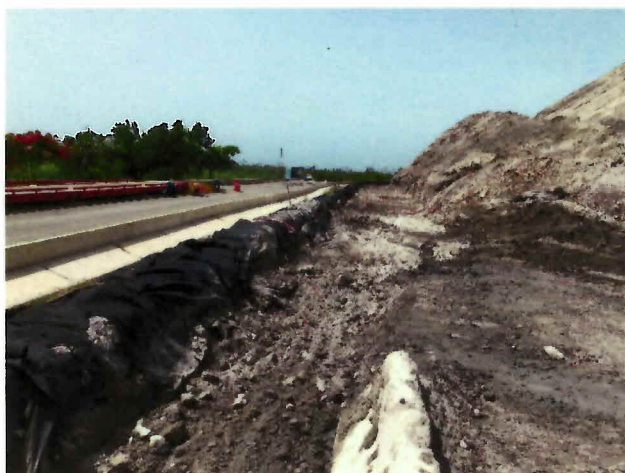
Picture 6

Finding: The super silt fence placed over the gabion structure along the east side of the Agremax pile was in disrepair. **Picture 6** depicts this observation.

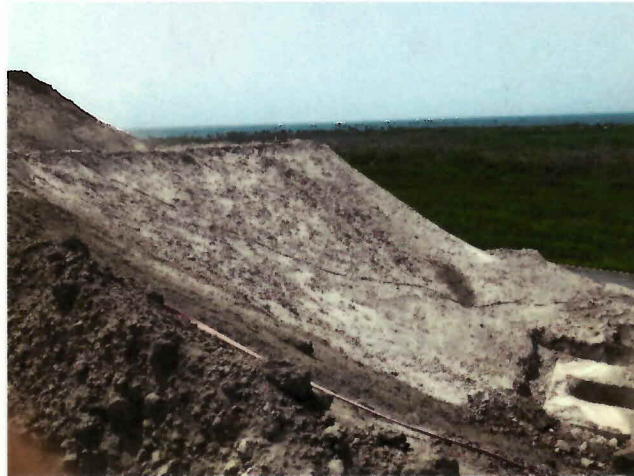
Picture 7

Findings: Most of the top areas of the CCR storage pile were not wet, covered with small particles, and dust was emitting into the air. Also, a large portion of the slopes on the north, west and south areas of the Agremax pile were not wet. **Picture 7** provides an example depicting these observations.

Note: This picture faces the west and southwest slopes.

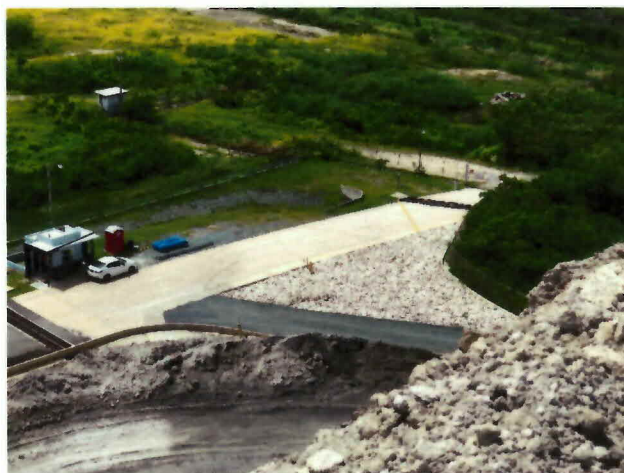
Picture 8

Findings: The berms located along the roadway to the top of the Agremax pile were observed with thin and loose Agremax, and very dry. The Inspector observed dust emission when heavy equipment transited thru the roadway. **Picture 8** depicts a segment of a berm with dry and loose Agremax.

Note: This picture also depicts the southeast side of the storage pile and a portion of the outfall 002 drainage area. This picture was taken from the highest portion of the storage pile.

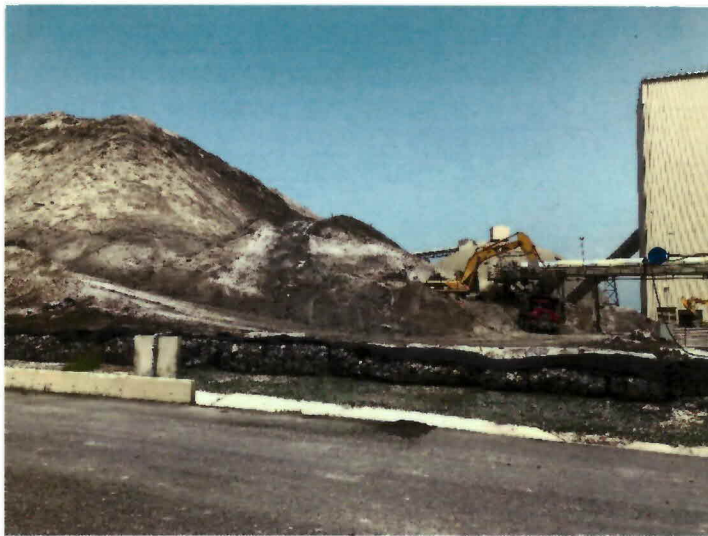
Picture 9

AES added a second roadway at the pile that runs westbound along the north side of the pile. The entryway is on the east side, and shown on **Picture 9**.

Note: Transportation of CCR to the top of the pile was taken place during the walkthrough of the storage pile.

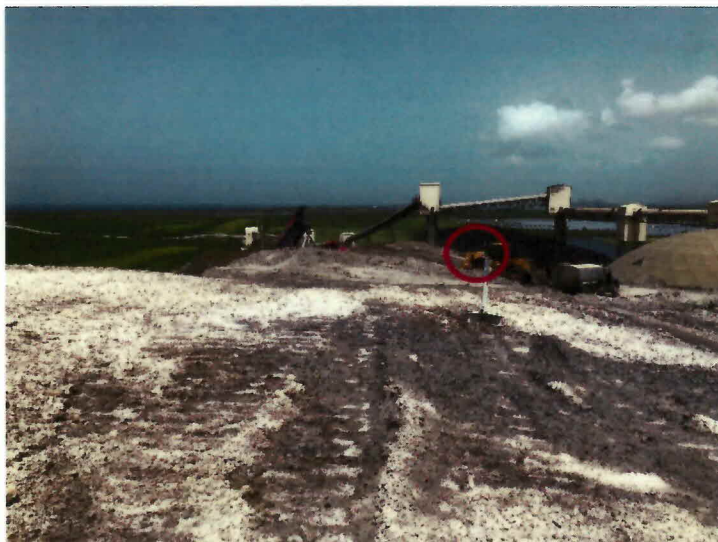
Picture 10

A water-mounted tank truck was observed spraying water in areas where the CCR was being deposited at the top of the storage pile. **Picture 10** depicts the truck, a spraying nozzle (not in service), and loose and dry CCR at the top of the storage pile. **Picture 11** depicts a spraying nozzle (not in service); and dry, loose and small CCR particles at the top of the storage pile. **Picture 12** depicts the added roadway on the northwest side, a slope showing dry conditions, the coal pile and the dome.

Note: Spraying nozzle was not spraying water.

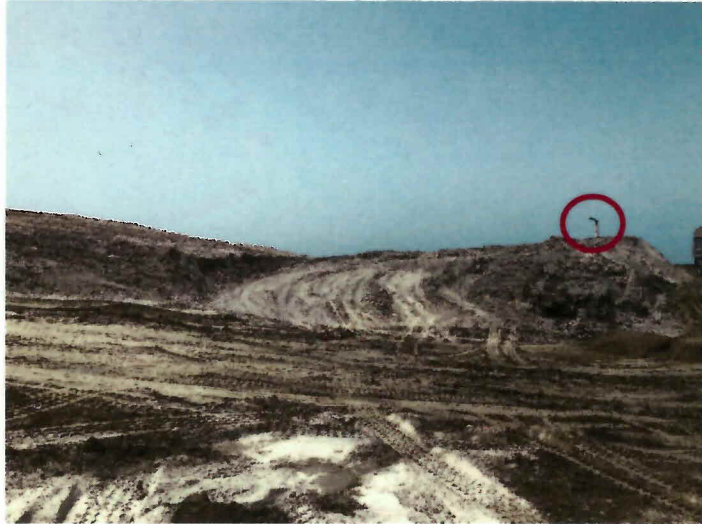
Picture 11

Note: Spraying nozzle was not spraying water.

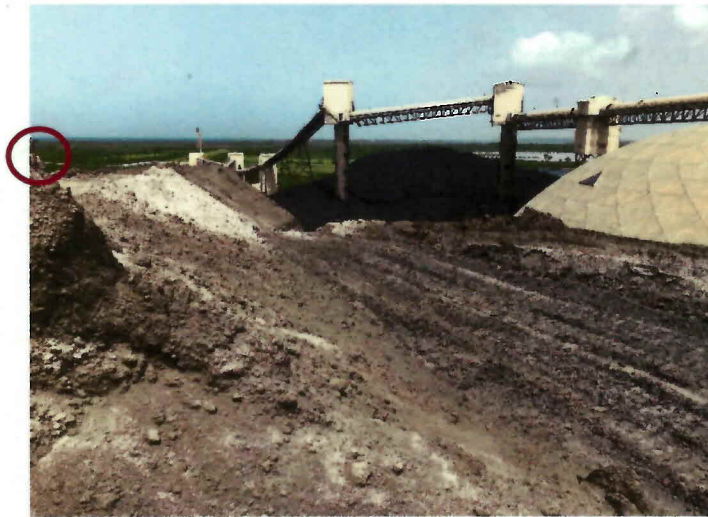
Picture 12

Note: Spraying nozzle was not spraying water.

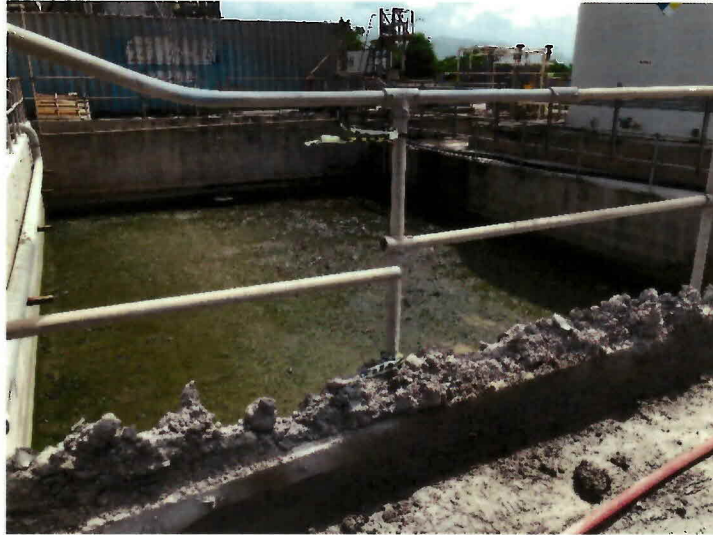
Picture 13

Finding: The diesel tank secondary containment lack good housekeeping practices, had a light-green colored water accumulation, and Agremax was stockpiled along the top of the concrete berm.

Note: Although not shown on this picture, the EPA Inspector observed two individuals working with what appeared to be a portable pump. See the red-colored hose laying on the ground.

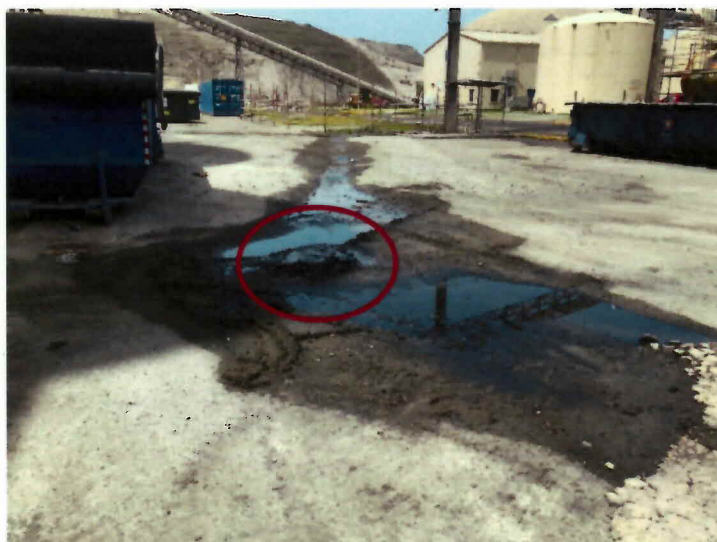
Picture 14

Findings: The inlet was surrounded with significant accumulation of sediment, which resulted from an excavation that was not provided with erosion control. Also, sediment and dust accumulation were observed in the roadway towards the Agremax pile **Picture 14** depicts the observation about the inlet. **Picture 15** depicts the observation about sediment and dust accumulation.

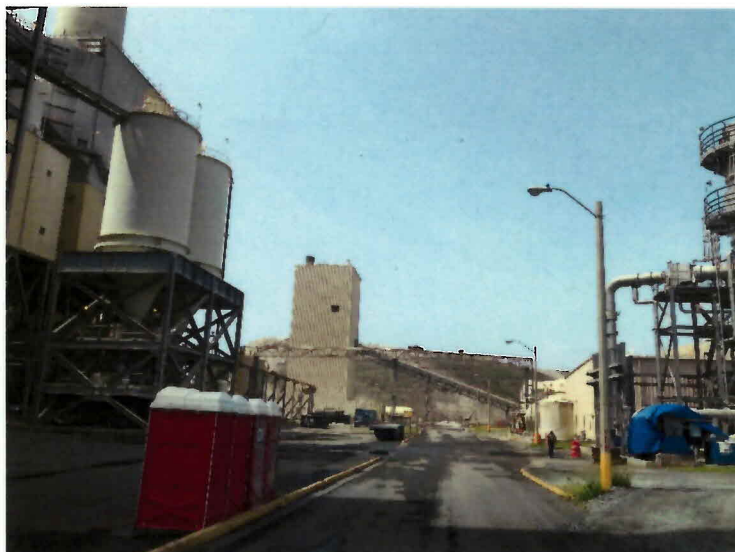
Picture 15

Note: The entrance to the cooling tower is also depicted in this picture.

Findings: The dirt road entrance to the cooling tower had exposed soil and lacked soil stabilization in several areas. The EPA Inspector did not see the sweeper-mounted vehicle in operation during the walkthrough of the Facility.
